EVAPORATIVE AIR COOLER SF-608RA CLEANING – WHEN UNIT IS LEAKING FROM THE BACK

If your evaporative air cooler Model SF-608RA (SN15xxxx) is leaking from the back panel, it is likely due to a clog.

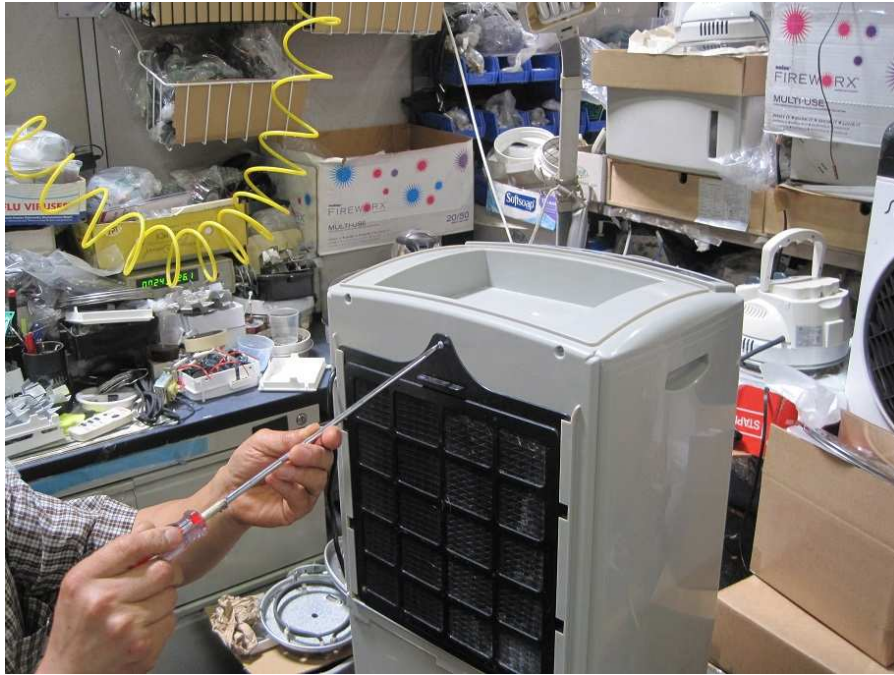
Remove the back panel. Begin by unscrewing the screw that holds the screen in place. This screw is located on the back of the unit, top center (refer to image below):

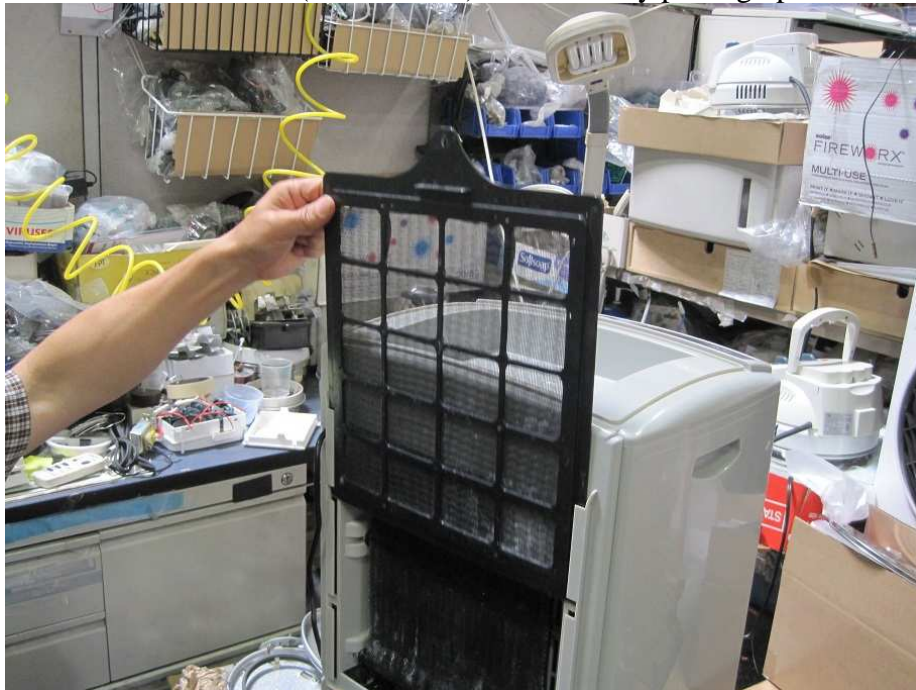
Remove dust filter (mesh screen) and frame by pulling upwards:

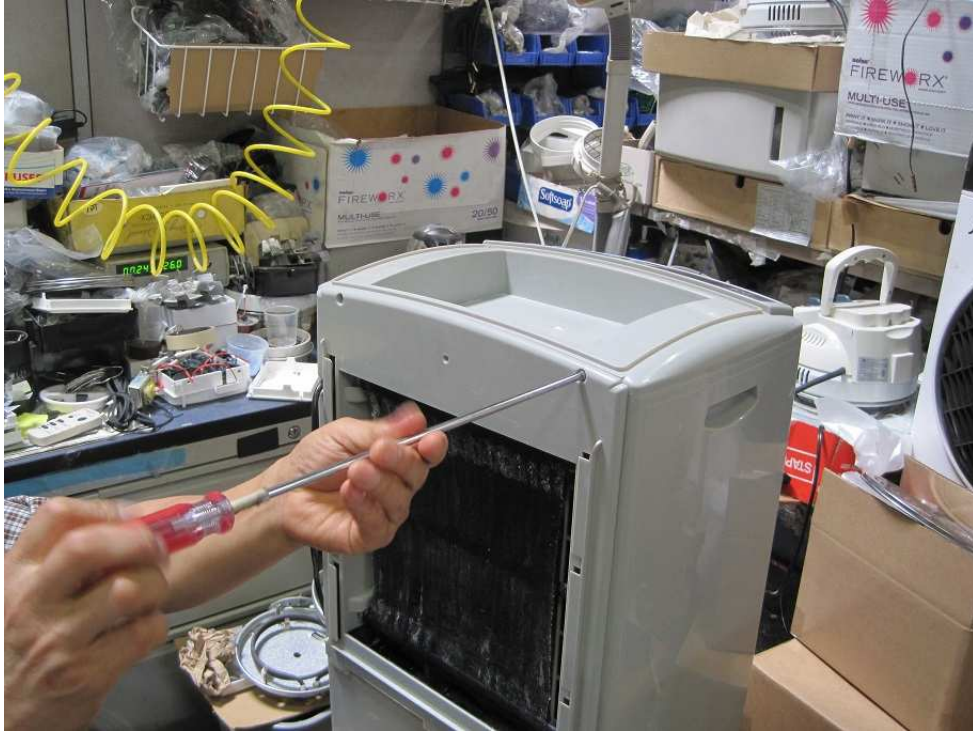
Now remove the back panel. Remove the screw in the upper right corner:

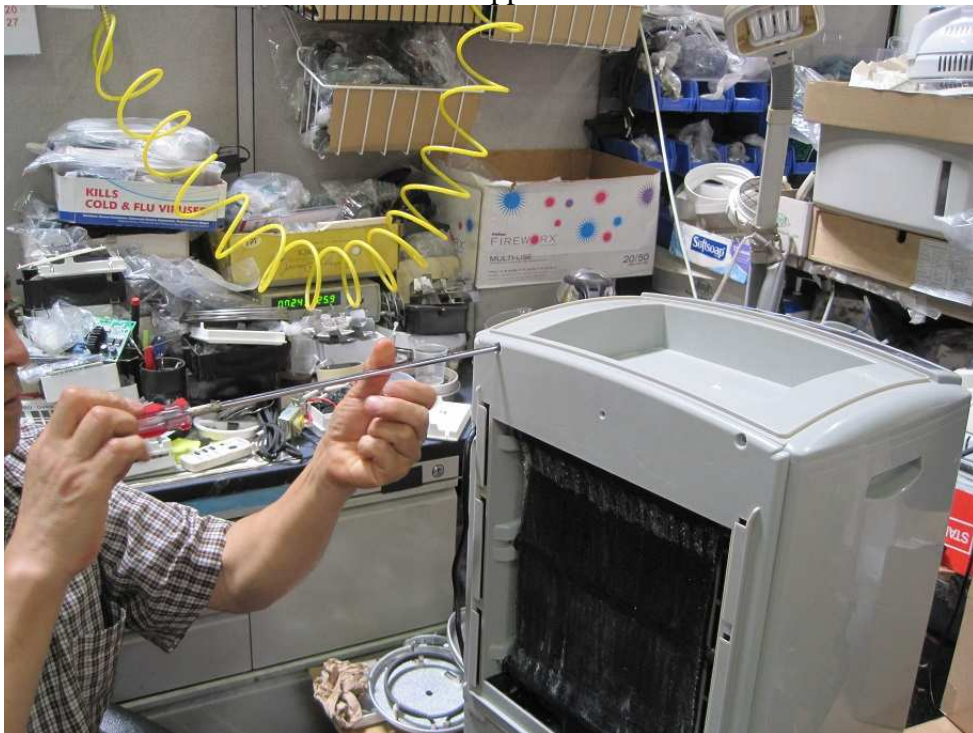
Then remove the screw in the upper left corner of the machine:

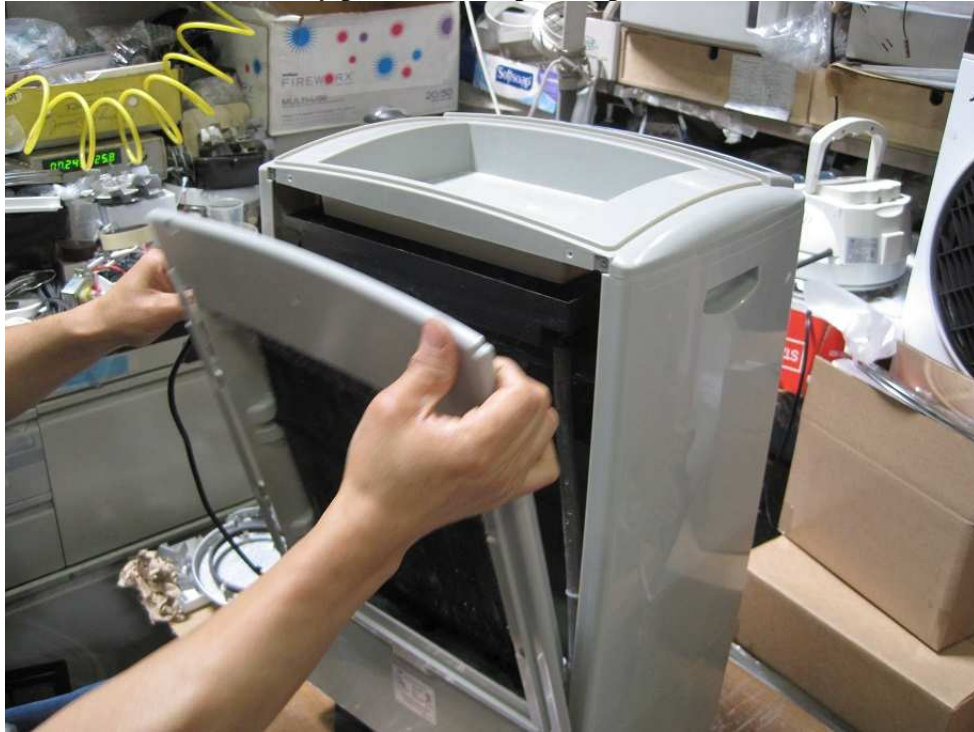
Gently pull the back panel up and out:

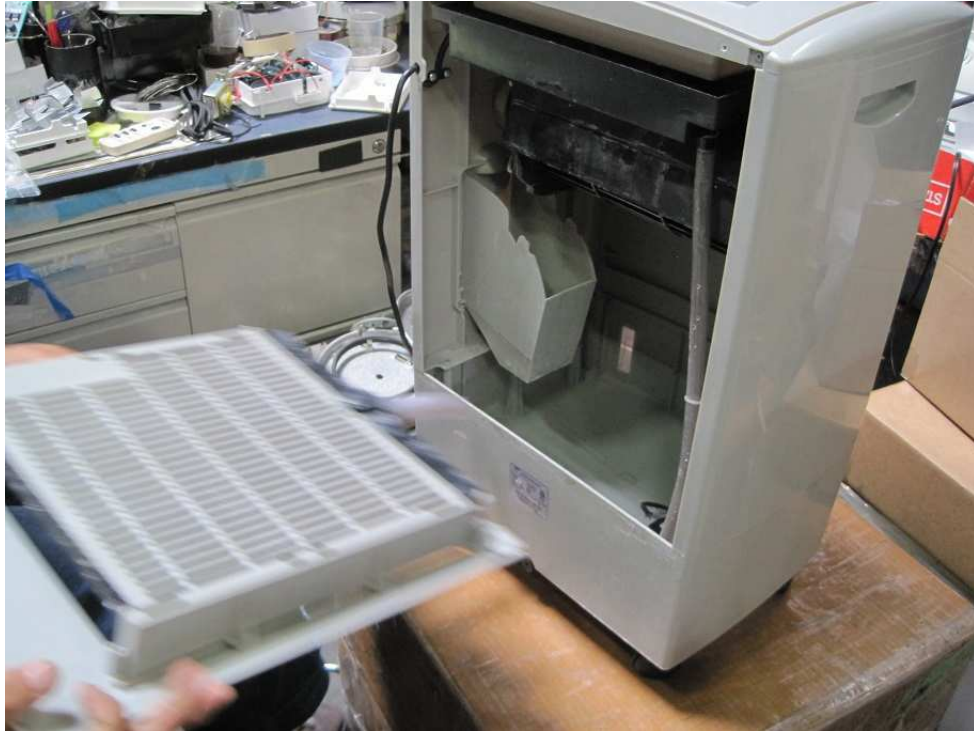
After removing the back panel (with water curtain attached) you will have access to the inside of the unit:

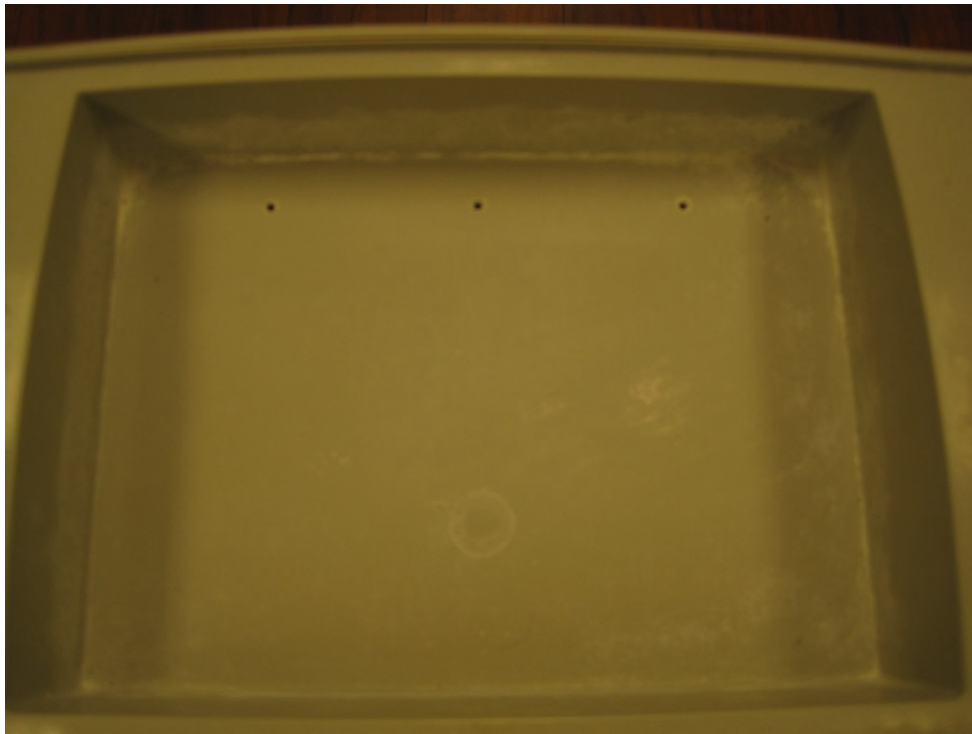
Image below shows the top ice box (with lid removed). Dust and mineral (from hard water) can easily cause build up and clog the 3 pin-size holes.

Unclog the three drain holes in the ice box as well:

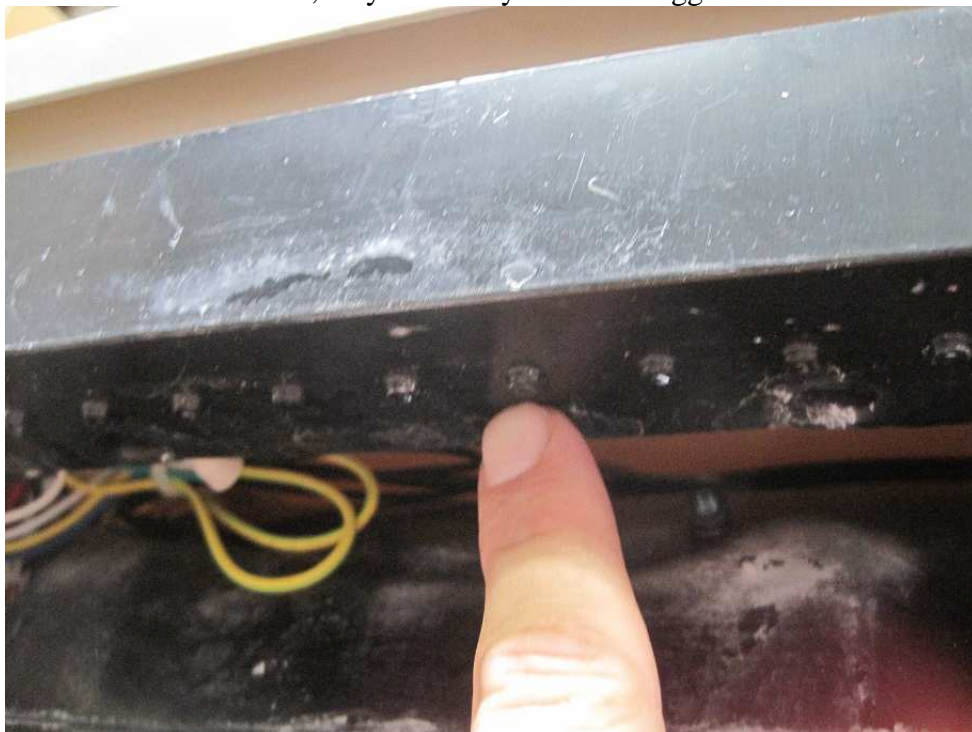
Image below shows the water tray (below the ice box) – this is where the water from the ice box drains into. The water then flows from the tray down over the water curtain. This photograph is taken from the ground up and shows the underside of the water tray. You can see a row of drain holes (where the finger is pointing to). As these holes are small, they can easily become clogged:

Please use a thin tool, such as a straitened paper clip, and poke through each drain hole to unclog them:

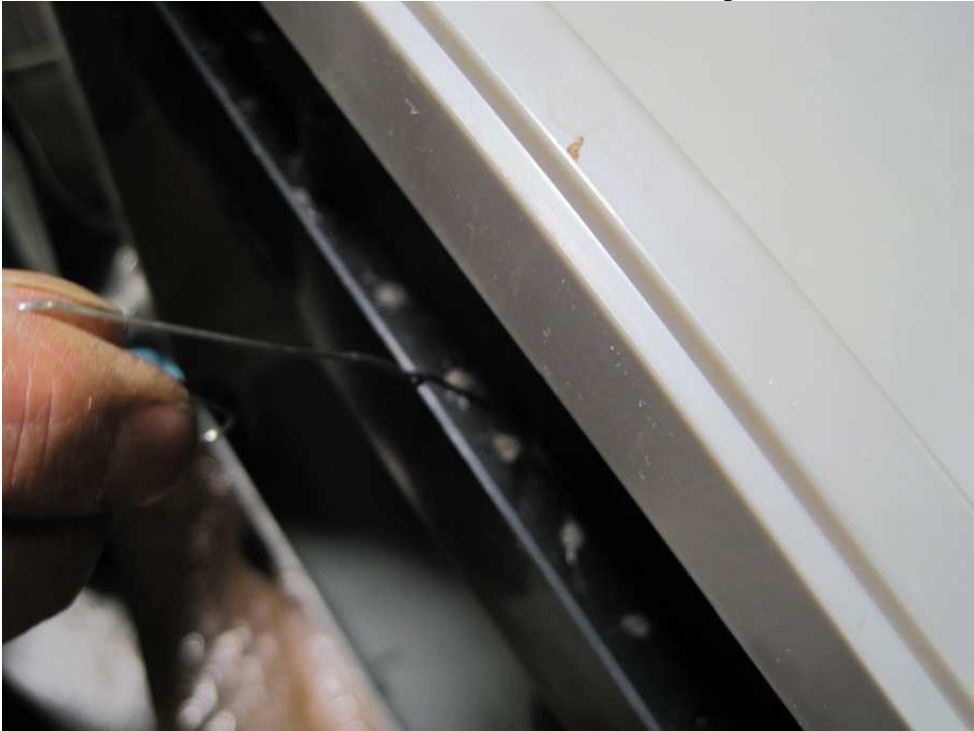
Do this from the underside as well as the top side:
